An Integrated Petrochemical complex with a load of app 90 MW and in-house Generation of app 72 MW is connected to grid power at 66kV. A typical distribution Key SLD is as follows.

This Plant experienced back to back faults in GTG 1 and GTG 2, Generator Main field excitation winding. The question being discussed in this Case Study-2 are;

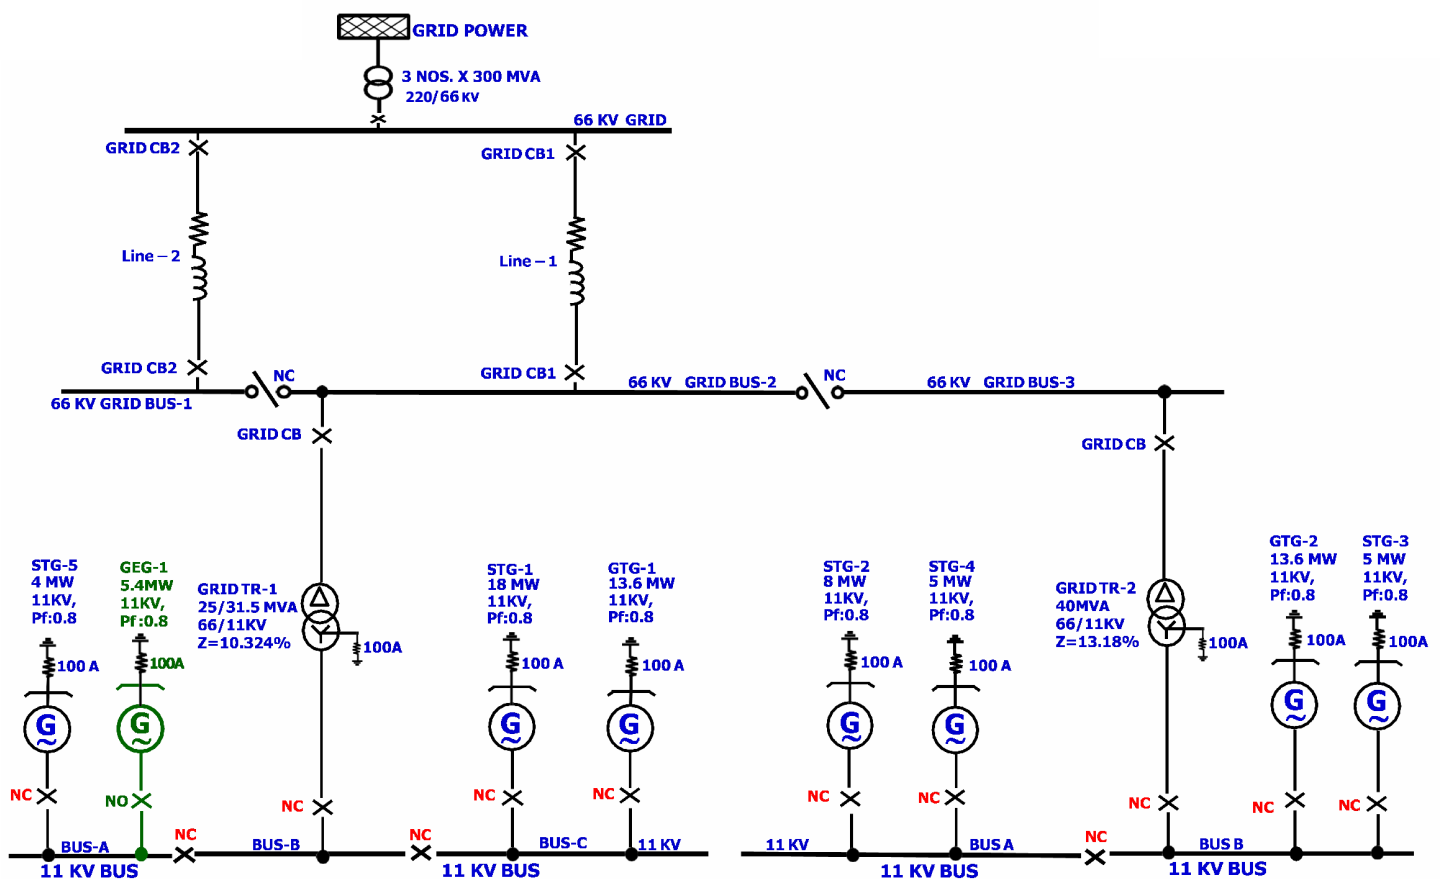
Review of Key SLD presented above indicates that Generators are directly connected to 11 kV Bus instead of Connecting through Generator Transformer to the bus.

As the Generators are directly connected to the 11 kV Distribution bus,

2.2.1 : All the faults within plant's 11 kV Distribution system are seen as direct terminal faults by Generator. This means that during every 11 kV distribution system faults, large electromagnetic forces are exerted between field poles, rotor and stator, resulting into the frictions between turns or turns to rotor body, thus the probability of rotor earth faults and failures.

2.2.2 : Generator 11 kV bus is also connected to Grid Power at 66 kV voltage system through 2 No's short 66 kV lines and 2 nos Power Transformers. So for all the faults in 66 kV lines, Grid 66 kV System or upstream 220 kV system, the fault current is contributed by the Generators. Again this results into large electromagnetic forces on field poles, winding and Stator and Rotor.

4.2 : Every Generator circuit shall be connected to 11 kV distribution system through Generator Transformer. This will relieve / reduce the electromagnetic forces directly experienced by the Generator winding as well as field poles.
