GT Failure Analysis

By Dr K Rajamani, Mr H C Mehta.
Power Linker, Mumbai.

One of the 21/420 kV, 275 MVA Single Phase Generator Transformers at a super thermal power plant failed during the clearance of 400kV Line fault. Thunderstorms and lightning preceded the fault in the area. **Power Linkers** performed **“Root Cause Analysis for this GT failure incident”**.

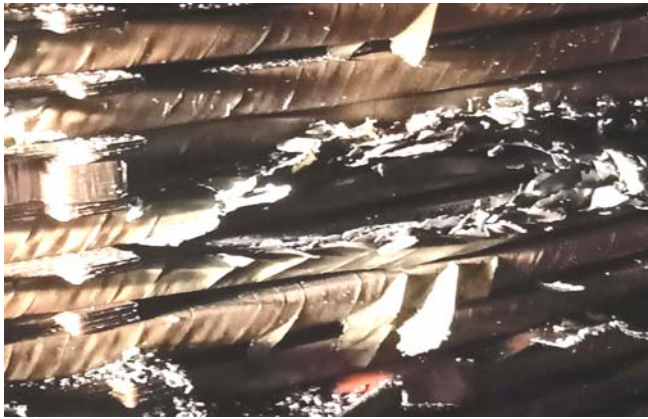
After that, the line auto-reclosed after one second. The auto reclosure was also successful. However, GT tripped on its internal fault while supplying a short circuit current to the line fault. Subsequently, when GT was inspected in the vendor's presence, extensive deformation of windings was observed.

Based on the analysis results of ETAP and PSCAD, it was concluded that the GT failed when supplying Line short circuit current. This is due to large short circuit forces exerted on winding, resulting in mechanical failure of GT winding structure and subsequent insulation failure. The winding had collapsed due to inadequately designed winding support structures against short circuit forces. Although the short circuit duration was short (3 cycles), the GT failed, confirming the poor Transformer design.

It was recommended to the customer to get the short circuit design of the new/rewind transformer vetted by an external Transformer Design consultant and or offer the new transformer for short circuit testing at a High Power Testing Laboratory in India or abroad.
